Ignition Issues (F09) with AdvantagePlus

Rheem has received reports of customers experiencing difficulty in getting proper ignition on AdvantagePlus units out of the box. This issue is often accompanied by an F09 fault showing on the controls. See below for troubleshooting.

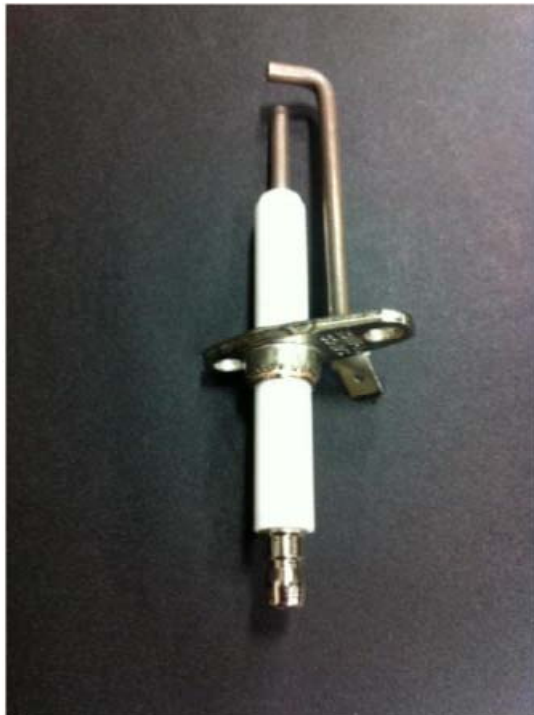
Natural Gas Igniter

The igniter that is present in the unit as it ships is a natural gas igniter. We have found that replacing with the LP Conversion Kit igniter will often address the issue. The replacement parts are contained in a special conversion kit sent with each water heater.
