Ignition Issues (F09) with AdvantagePlus

Rheem has received reports of customers experiencing difficulty in getting proper ignition on AdvantagePlus units out of the box. This issue is often accompanied by an F09 fault showing on the controls. See below for troubleshooting.

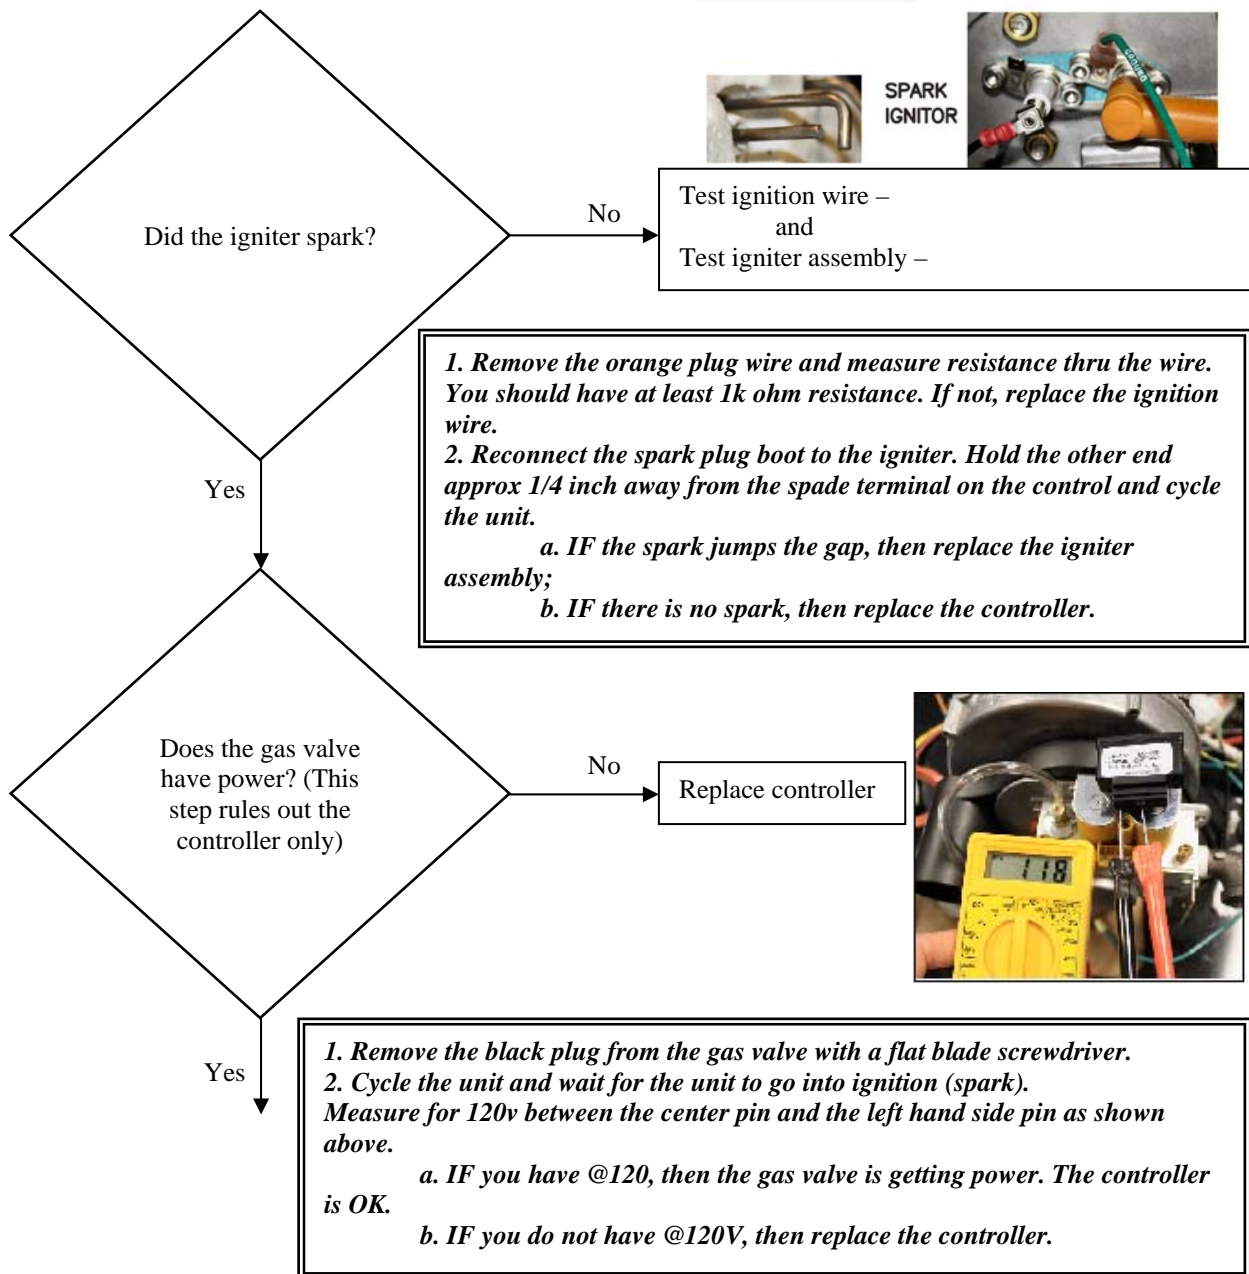
This lockout code means maximum ignition attempts. The unit has cycled for main burner three times without flame rectification. The operative term here is flame rectification. Remember, the control checks many things such as the blower, venting, gas valve, ECO, etc, that would produce their unique error codes. Things to check:

- Does the unit have fuel?
- Is the fuel isolation valve ON?
- Is the orange igniter wire connected at both ends?
- Is the yellow flame probe wire connected at both ends?
- Is the green ground (rectification circuit) wire solidly connected at both ends?
- Is the gas valve Molex connected to the board?

The igniter that is present in the unit as it ships is a natural gas igniter. We have found that replacing with the LP Conversion Kit igniter will often address the issue. The replacement parts are contained in a special conversion kit sent with each water heater.
